BROCHS IN CAITHNESS

DUNBEATH BROCH ICON OF THE NORTH

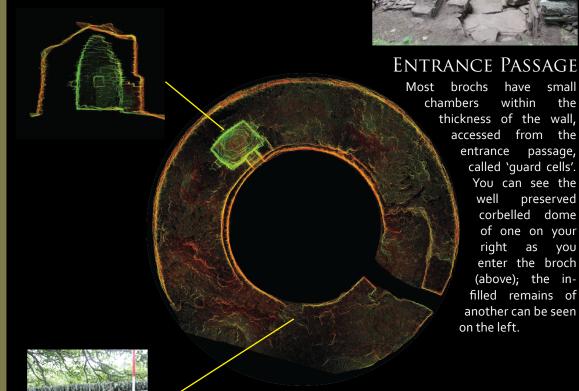
INTRA-MURAL CELL

Step into the intra-mural cell (below), accessed from inside the broch. Whilst most brochs have cells within their walls, the Dunbeath example is of an unusual form, suggesting it dates to a later period of remodelling.
